UNM Historic Preservation Committee guidance for the treatment of windows and review submittal requirements

The Repair of Historic Wooden Windows

The Repair and Thermal Upgrading of Historic Steel Windows

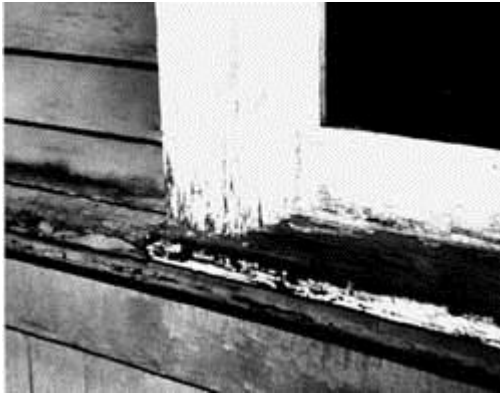
Deterioration of poorly maintained windows usually begins on horizontal surfaces and at joints, where water can collect and saturate the wood. Photo: NPS files.

Many factors such as poor design, moisture, vandalism, insect attack, and lack of maintenance can contribute to window deterioration, but moisture is the primary contributing factor in wooden window decay. All window units should be inspected to see if water is entering around the edges of the frame and, if so, the joints or seams should be caulked to eliminate this danger. The glazing putty should be checked for cracked, loose, or missing sections which allow water to saturate the wood, especially at the joints. The back putty on the interior side of the pane should also be inspected, because it creates a seal which prevents condensation from running down into the joinery. The sill should be examined to insure that it slopes downward away from the building and allows water to drain off. In addition, it may be advisable to cut a dripline along the underside of the sill. This almost invisible treatment will insure proper water runoff, particularly

if the bottom of the sill is flat. Any conditions, including poor original design, which permit water to come in contact with the wood or to puddle on the sill must be corrected as they contribute to deterioration of the window.

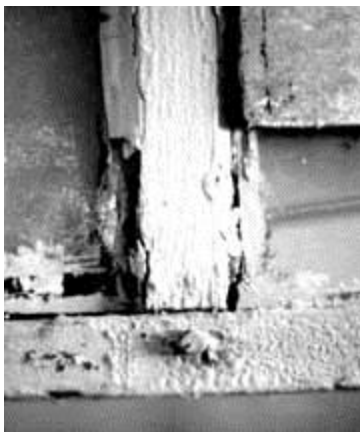
This historic double-hung window has many layers of paint, some cracked and missing putty, slight separation at the joints, broken sash cords, and one cracked pane. Photo: NPS files.

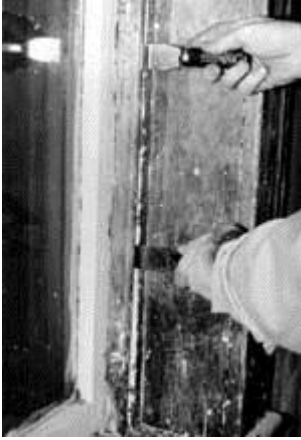
After removing paint from the seam between the interior stop and the jamb, the stop can be pried out and gradually worked loose using a pair of putty knives as shown. Photo: NPS files.

Paint removal should begin on the interior frames, being careful to remove the paint from the interior stop and the parting bead, particularly along the seam where these stops meet the jamb.

This can be accomplished by running a utility knife along the length of the seam, breaking the paint bond. It will then be much easier to remove the stop, the parting bead and the sash. The interior stop may be initially loosened from the sash side to avoid visible scarring of the wood and then gradually pried loose using a pair of putty knives, working up and down the stop in small increments. With the stop removed, the lower or interior sash may be withdrawn. The sash cords should be detached from the sides of the sash and their ends may be pinned with a nail or tied in a knot to prevent them from falling into the weight pocket.

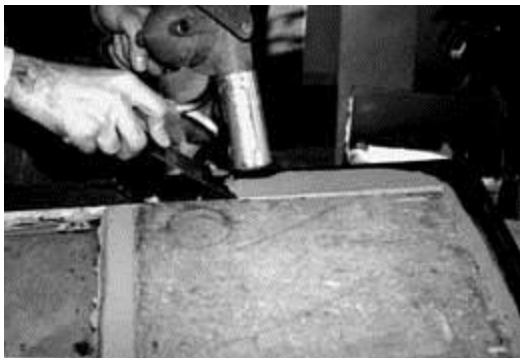
Sash can be removed and repaired in a convenient work area. Paint is being removed from this sash with a hot air gun. Photo: NPS files.

The sash can be stripped of paint using appropriate techniques, but if any heat treatment is used, the glass should be removed or protected from the sudden temperature change which can cause breakage. An overlay of aluminum foil on gypsum board or asbestos can protect the glass from such rapid temperature change. It is important to protect the glass because it may be historic and often adds character to the window. Deteriorated putty should be removed manually, taking care not to damage the wood along the rabbet. If the glass is to be removed, the glazing points which hold the glass in place can be extracted and the panes numbered and removed for cleaning and reuse in the same openings. With the glass panes out, the remaining putty can be removed and the sash can be sanded, patched, and primed with a preservative primer. Hardened putty in the rabbets may be softened by heating with a soldering iron at the point of removal. Putty remaining on the glass may be softened by soaking the panes in linseed oil, and then removed with less risk of breaking the glass. Before reinstalling the glass, a bead of glazing compound or linseed oil putty should be laid around the rabbet to cushion and seal the glass. Glazing compound should only be used on wood which has been brushed with linseed oil and primed with an oil based primer or paint. The pane is then pressed into place and the glazing points are pushed into the wood around the perimeter of the pane.

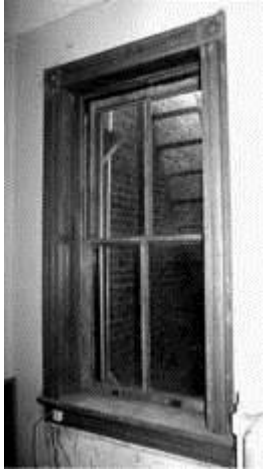
Following the relatively simple repairs, the window is weathertight, like new in appearance, and serviceable for many years to come. Photo: NPS files.

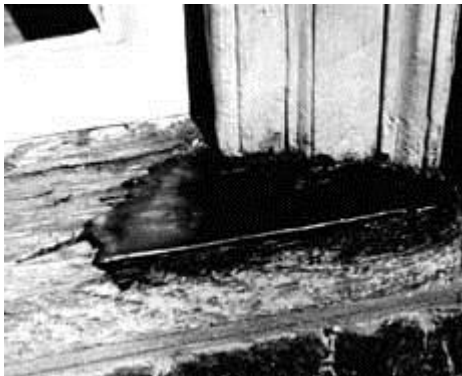
This illustrates a two-part epoxy patching compound used to fill the surface of a weathered sill and rebuild the missing edge. When the epoxy cures, it can be sanded smooth and painted to achieve a durable and waterproof repair. Photo: NPS files.

When sills or other members exhibit surface weathering they may also be built-up using wood putties or homemade mixtures such as sawdust and resorcinol glue, or whiting and varnish. These mixtures can be built up in successive layers, then sanded, primed, and painted. The same caution about proper slope for flat surfaces applies to this technique.

Wood may also be strengthened and stabilized by consolidation, using semirigid epoxies which saturate the porous decayed wood and then harden. The surface of the consolidated wood can then be filled with a semirigid epoxy patching compound, sanded and painted. Epoxy patching compounds can be used to build up missing sections or decayed ends of members. Profiles can be duplicated using hand molds, which are created by pressing a ball of patching compound over a sound section of the profile which has been rubbed with butcher's wax. This can be a very efficient technique where there are many typical repairs to be done. The process has been widely used and proven in marine applications; and proprietary products are available at hardware and marine supply stores. Although epoxy materials may be comparatively expensive, they hold the promise of being among the most durable and long lasting materials available for wood repair. More information on epoxies can be found in the publication "Epoxies for Wood Repairs in Historic Buildings," cited in the bibliography.

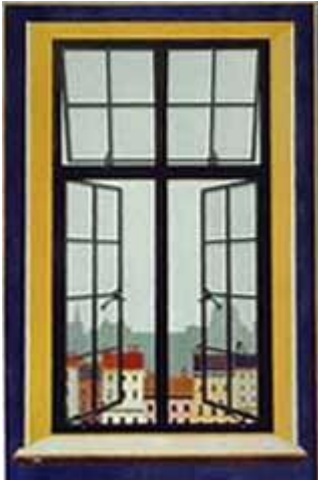
Metal casement window from "Hope's Metal Windows and Casements, 1818-1926." Photo: Courtesy, Hope's Windows, Inc.

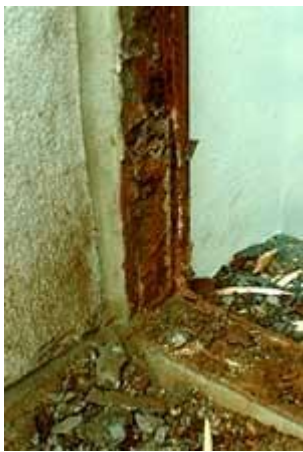
A severely deteriorated frame, such as this, can be replaced in kind. Photo: Henry Chambers, AIA

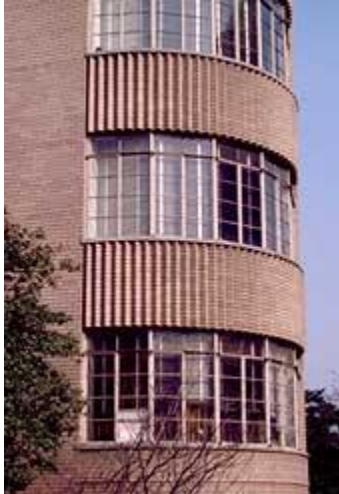
The historic steel sash is shown in place, prior to its removal and replacement with inappropriate aluminum sash (see below). Photo: NPS files.

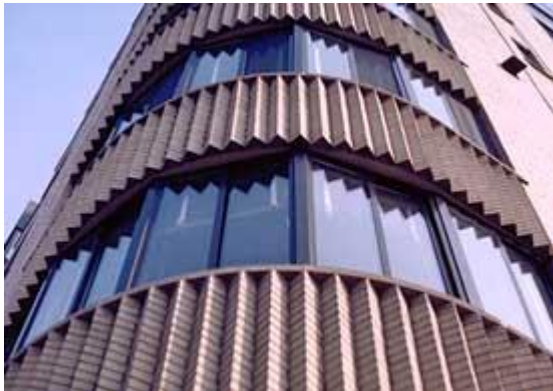
The historic steel sash (see photo above) was removed and replaced with modern aluminum sash, resulting in a negative visual impact on the building's historic character. Photo: NPS files.

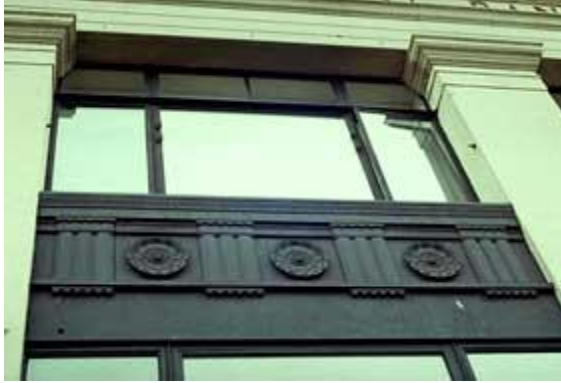
Historic steel sash can be fitted with dual glazing to improve thermal efficiency. Photo: NPS files.

Another weatherization treatment is to install an additional layer of glazing to improve the thermal efficiency of the existing window. The decision to pursue this treatment should proceed from careful analysis. Each of the most common techniques for adding a layer of glazing will effect approximately the same energy savings (approximately double the original insulating value of the windows); therefore, cost and aesthetic considerations usually determine the choice of method. Methods of adding a layer of glazing to improve thermal efficiency include adding a new layer of transparent material to the window; adding a separate storm window; and replacing the single layer of glass in the window with thermal glass.

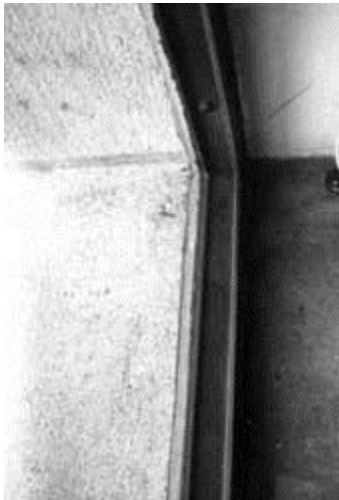
This is a successful replacement in kind of the deteriorated frame shown above. Photo: Henry Chambers, AIA.

In the case of significant windows, replacement in kind is essential in order to maintain the historic character of the building. However, for less significant windows, replacement with compatible new windows may be acceptable. In selecting compatible replacement windows, the material, configuration, color, operability, number and size of panes, profile and proportion of metal sections, and reflective quality of the original glass should be duplicated as closely as possible.
